Manhole Inspection Summary

Manhole # S71U__015MH

Insp Date: **4/16/08 2:07 PM**

Location Address: **6706 Brentwood Ave.**

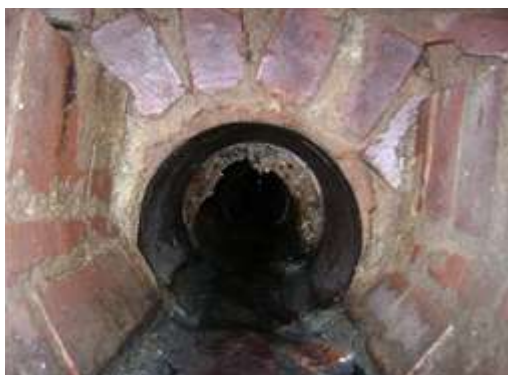
Roots fine

Roots fine barrel 7:00-4:00 outgoing 12 o'clock

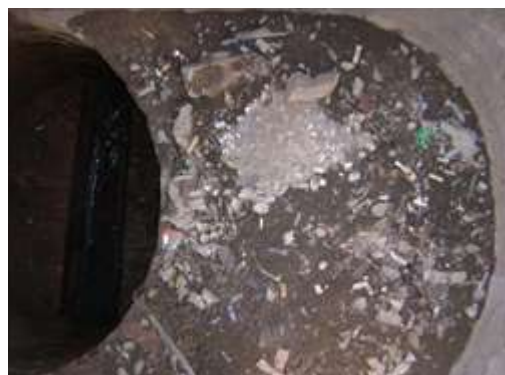
Defect 1

Comments **3 FT DOWN THERE IS A 4 FT LONG SHELF.**

4 ft shelf

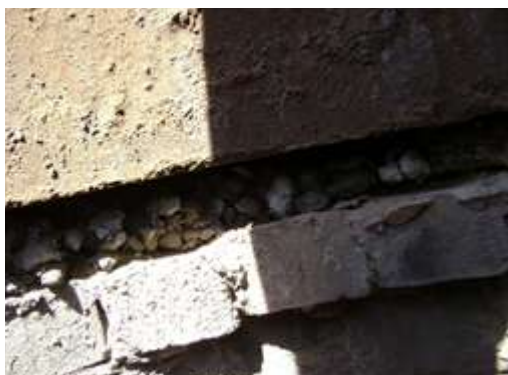
Defect 2

loose bricks / missing mortar at frame seal

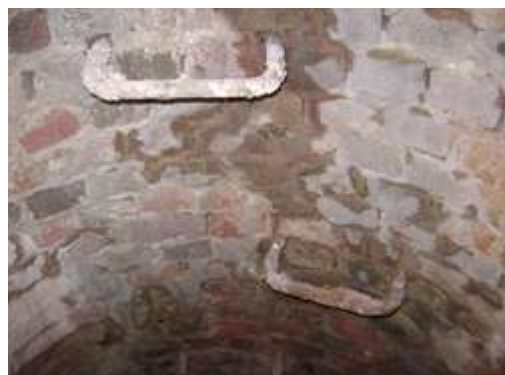
Defect 4

infiltration on barrel wall

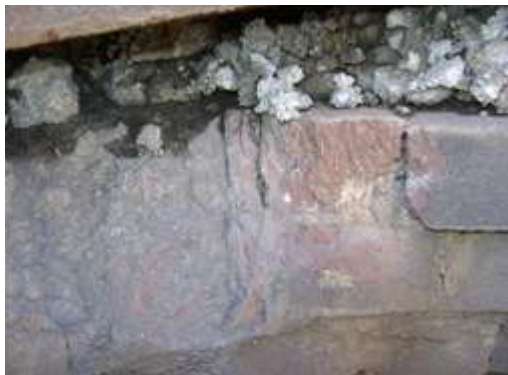
Defect 3

Infiltration: ☐ None ☒ **Joint** ☐ Cracks ☐ Mortar ☐ Roots ☐ Wall

infiltration under frame

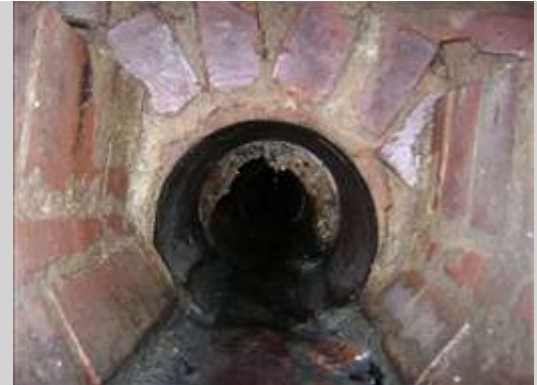
12 O'Clock Outflow

roots medium connection 8:00-5:00
